The Urine Diversion Project at GTZ Headquarter, Eschborn, Germany

GTZ ecosan Programme

Technical components installed (I)

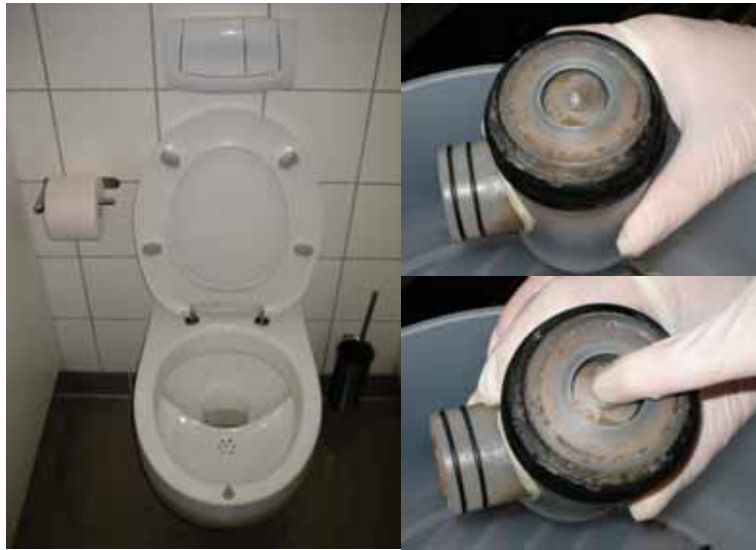
50 low-flush urine diversion toilets (Roediger) (1-3 L per urine flush, 6-9 L per faeces flush). Set during installation

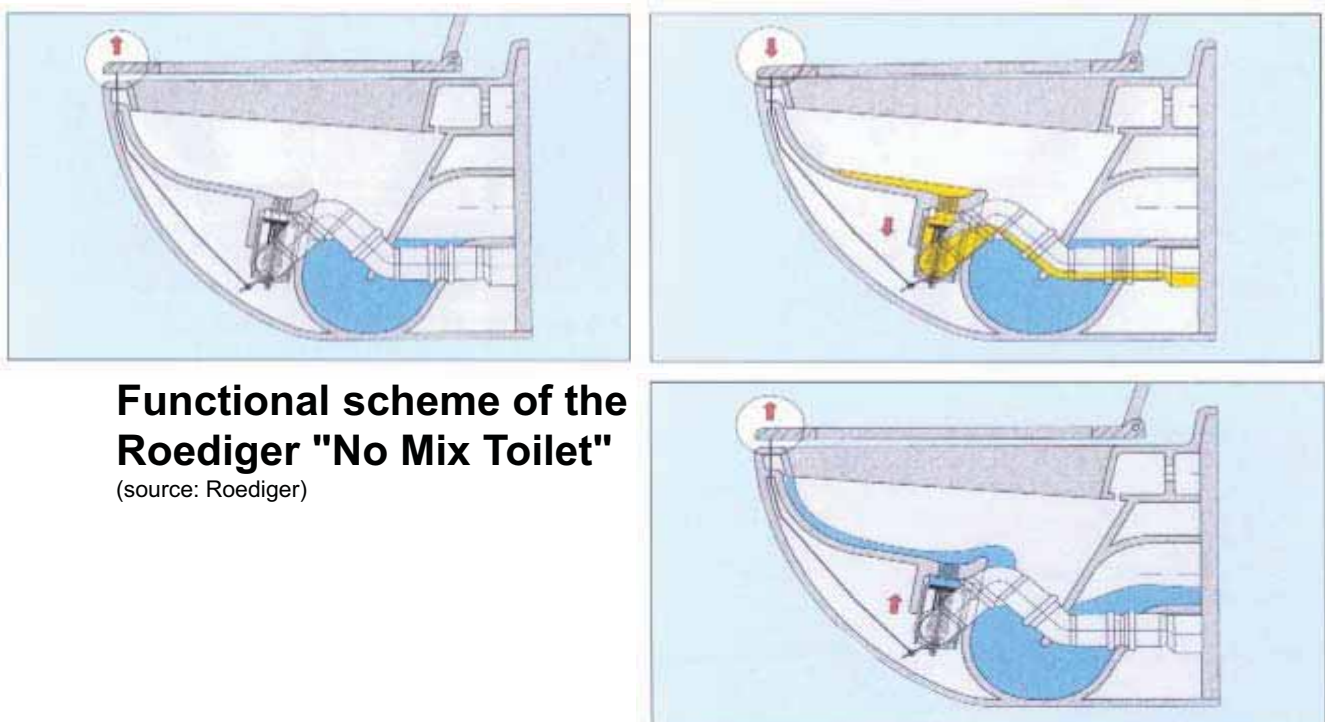
Functional scheme of the Roediger "No Mix Toilet"
(source: Roediger)

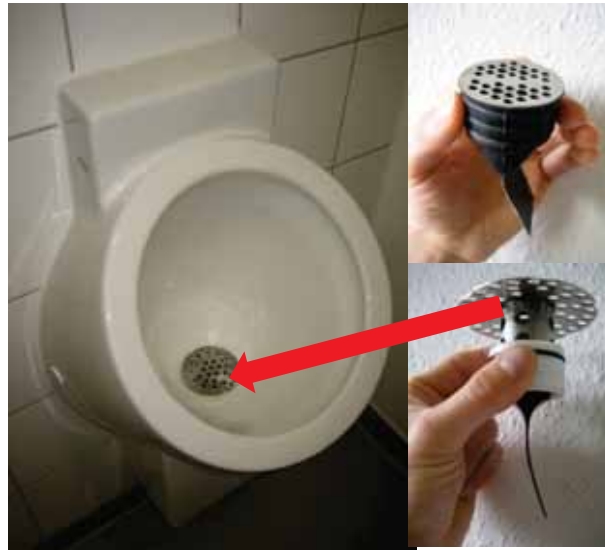
2nd generation

1st generation

23 waterless urinals (Keramag)

Problems with the waterless urinals

- if maintenance neglected: **precipitations** on rubber tube odour seal (not closing properly anymore)
- leakage of the drainage cylinder due to small vertical downwards movements of urinal on wall
- some pubic hairs in the urinal sticking to surface

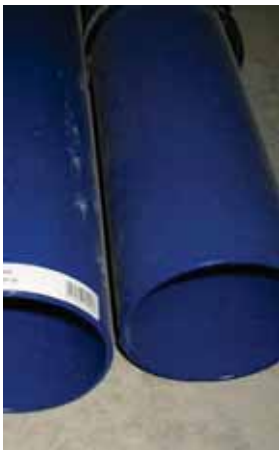
Urine collection pipes 50, 80 and 100 mm made of cast iron with enamel coating

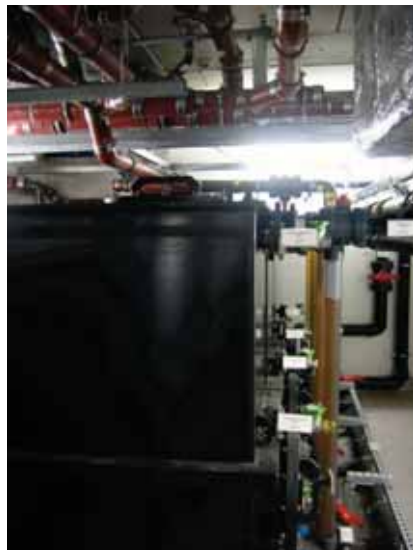
PE urine storage tanks (4 x 2500 L)

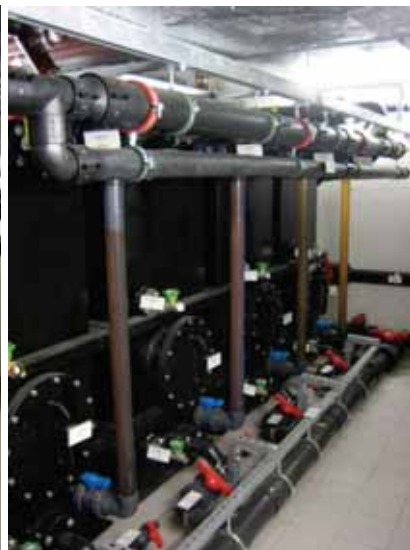
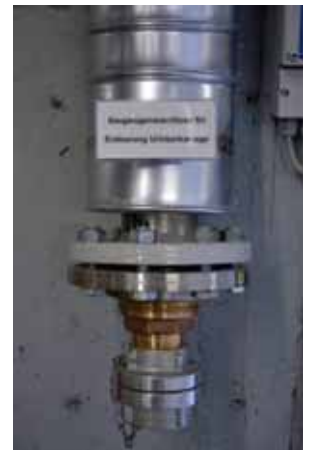
Docking station for vacuum tanker

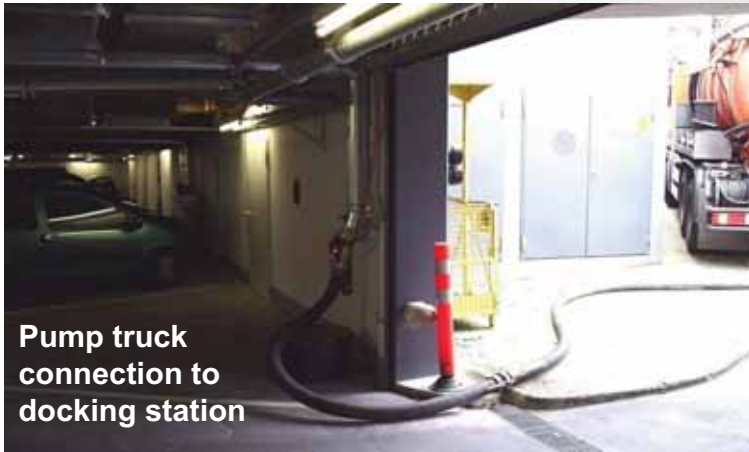
Pump truck connection to docking station

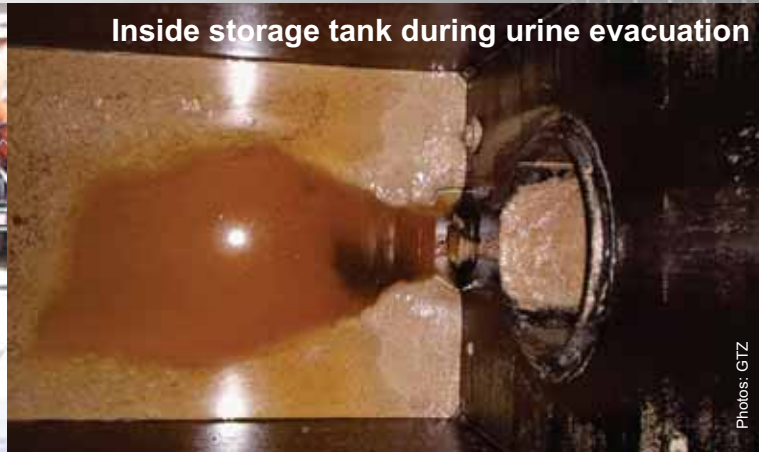
Inside storage tank during urine evacuation

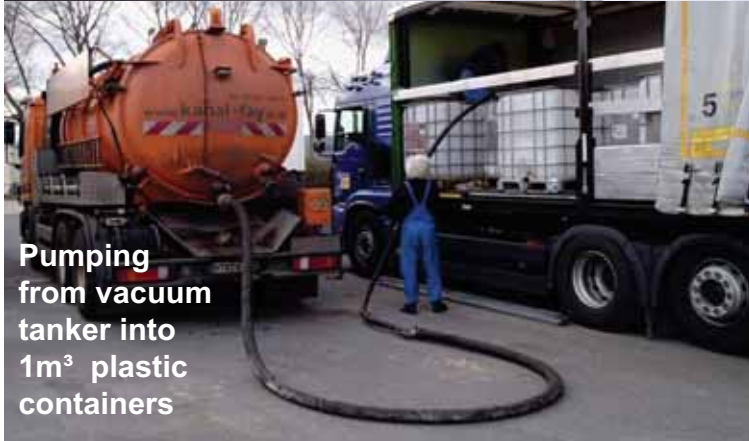
Pumping from vacuum tanker into 1m³ plastic containers

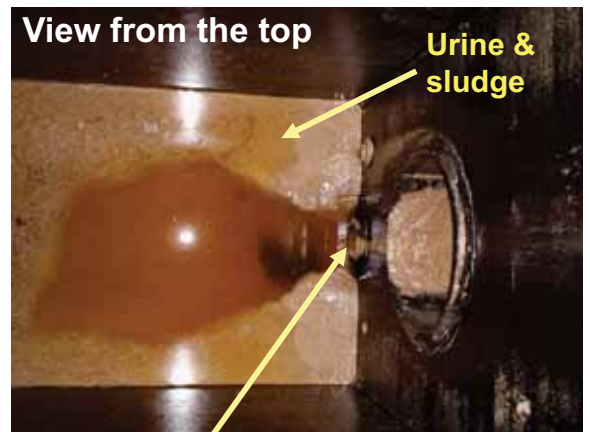
View from the top

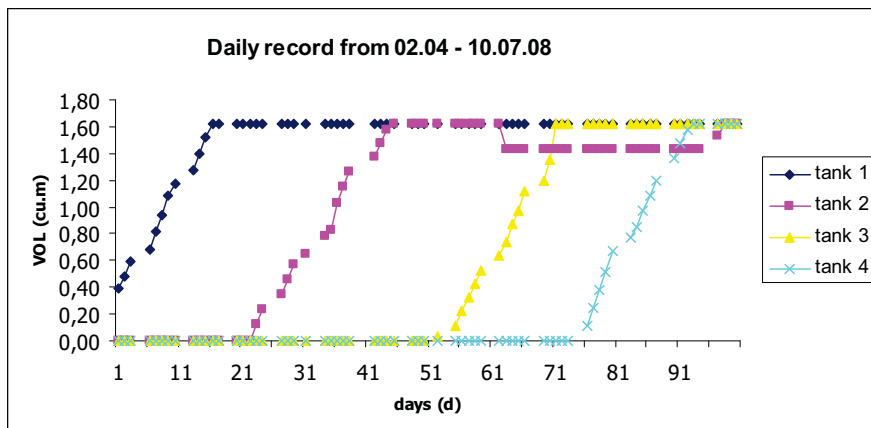
Urine & sludge

- approx. 90 days filling time
→ approx. 110 L/d urine
- emptying by vacuum tanker
- precipitation inside of storage tank
- MAP production tests at Uni RWTH Aachen and treatment tests at FH Gießen

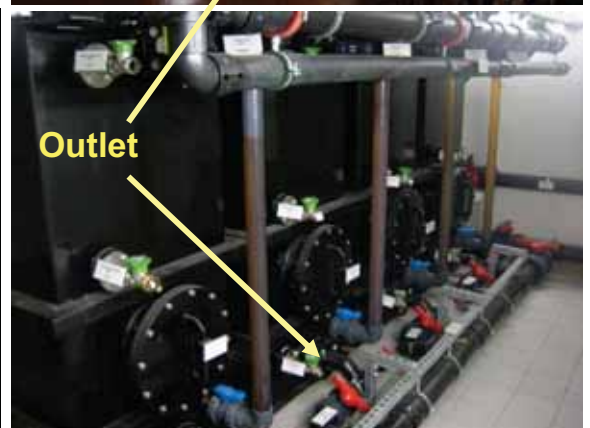
Outlet

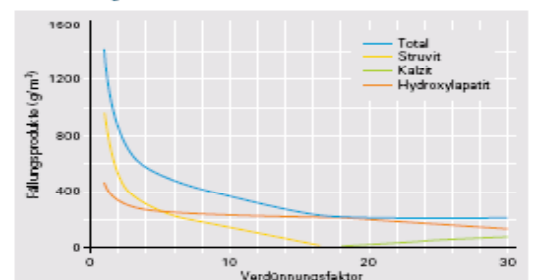
Abb. 2: Die Ausfällung von Struvit, Hydroxylapatit und Kalzit ist abhängig von der Verdünnung des Urins.

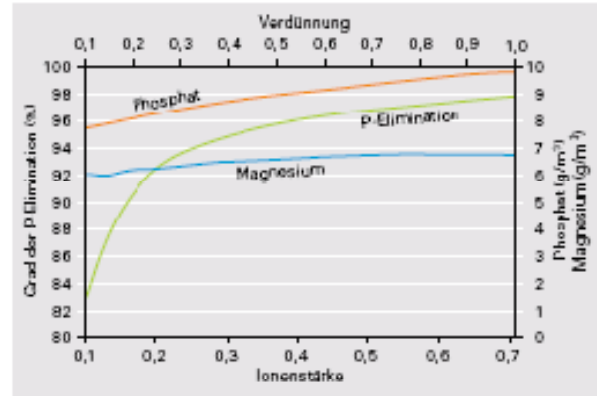
Abb. 1: Die gelösten Phosphat- und Magnesiumkonzentrationen nach der Struvit-Fällung sind abhängig von der Verdünnung des Urins mit Spülwasser (1 = unverdünnt, 0,1 = 10-fachverdünnt). Ausgangskonzentrationen der Nährstoffe im unverdünnten Urin: Phosphat = 440 g P/m³; Ammonium = 7850 g N/m³. Zugabe einer äquimolaren Menge von Magnesiumchlorid (bezogen auf Phosphat).
